Water Quality Management Plan
for the 2008 Water Year

2009 Water Quality Implementation Report

Provo River, Deer Creek Reservoir and Jordanelle Reservoir

Prepared By:
Desert Rose Environmental, LLC

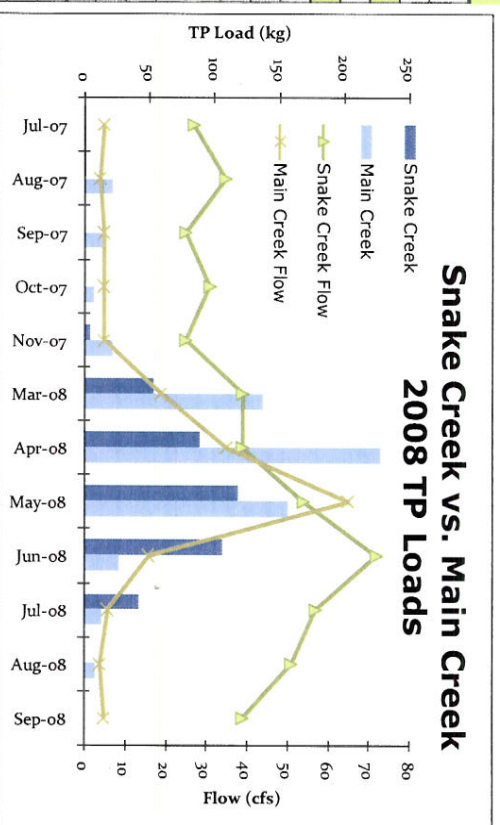
Snake Creek & Main Creek

Main creek continues to exhibit high total phosphorus concentrations. Compared to Snake Creek, which has much higher flows, Main Creek's overall loading is higher. See chart at top. A Watershed Plan is being prepared to identify mitigation measures that may be put into place to control phosphorus coming from Main Creek.
